## APPLICATION NOTE

### Washington PUD Relies on Thermal Imaging to Keep the Lights on for Residents

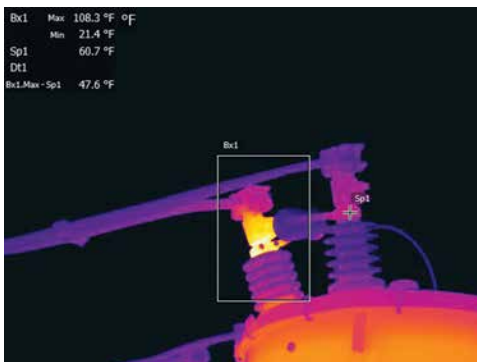
*The bushing atop a regulator on the C-phase circuit at PUD 3's Mountain View substation was failing. Without timely repairs, this failed connection would have caused \$40,000 in damage and cut service to about 3,000 customers.*

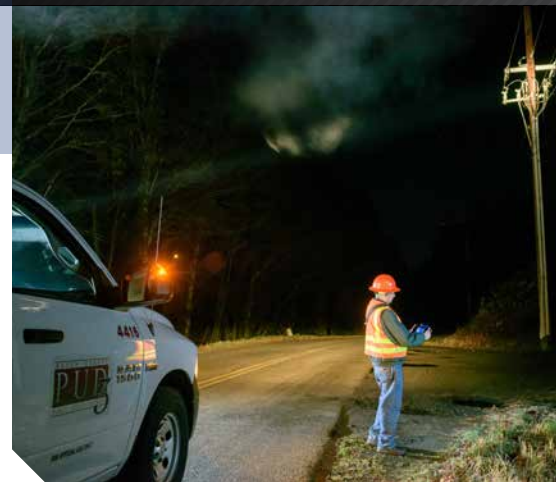
*PUD 3 engineers perform the majority of their scans at night when the electrical load is greater.*

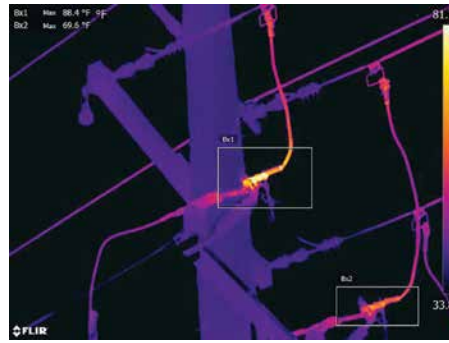
Engineers discovered four hot spots on this gang-operated switch. Two of the phases had failing hot taps and jumpers, and two of the three switches were failing. A failure on this structure would have affected nearly 1,500 customers.

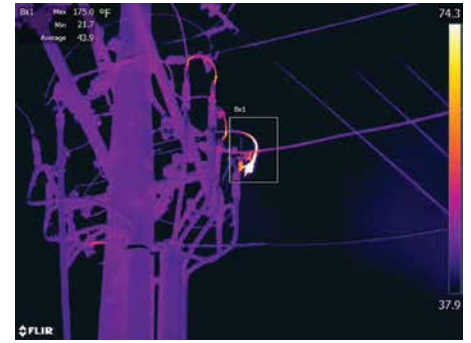
A failing hot tap on the connection between an overhead to underground power line on a riser structure at PUD 3's Union River Substation needed to be repaired quickly to avoid an outage that would have affected about 1,000 customers.

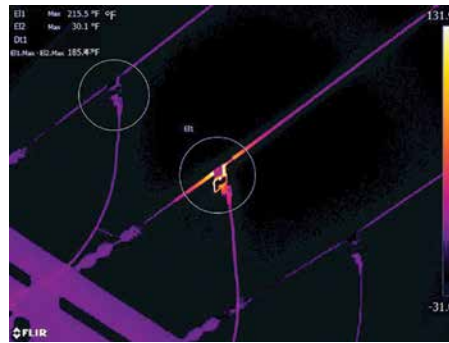
The center-phase hot tap is showing imminent failure. This hot line-clamp, or bail, connects two circuits together. A poor connection on the line clamp is causing heating on the primary line. Had it failed, 2,250 customers would have lost service.

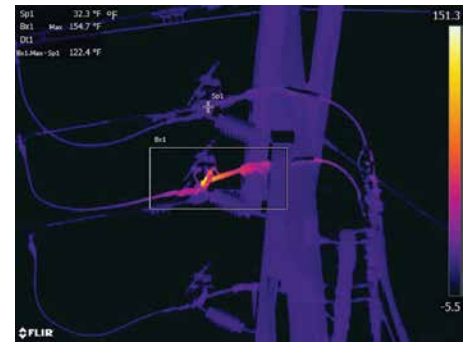
The center phase of this gang-operated switch at PUD 3's Pioneer substation was failing. If not repaired the switch would have burned up, cutting power to about 1,600 customers and posing a safety hazard to linemen who had to operate it.

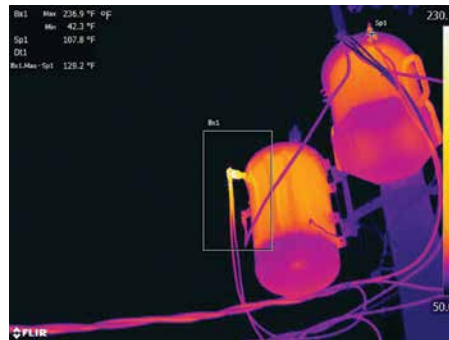
This image of a three-phase transformer bank at a local cedar mill shows a bad secondary bushing on one of the transformers. If this had not been discovered, the result would have been a costly shut down for the mill – thousands of dollars per hour of lost productivity.

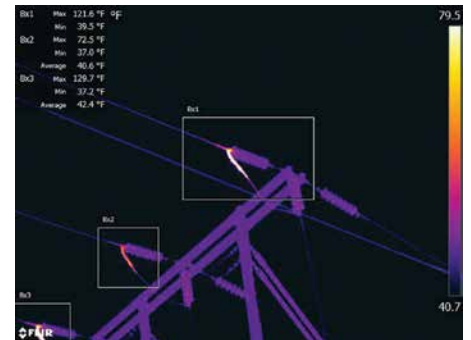
Thermal imaging helped PUD 3 locate this failing dead-end bell on 115,000 V power lines before it caused a lengthy outage for nearly 2,000 customers.
