FLIR CAMERAS SPOT TRESPASSERS ON BELGIUM'S BUSIEST RAIL CONNECTION

BELGIUM'S BUSIEST RAILWAY LINE

THERMAL IMAGING RAILWAY CAMERA

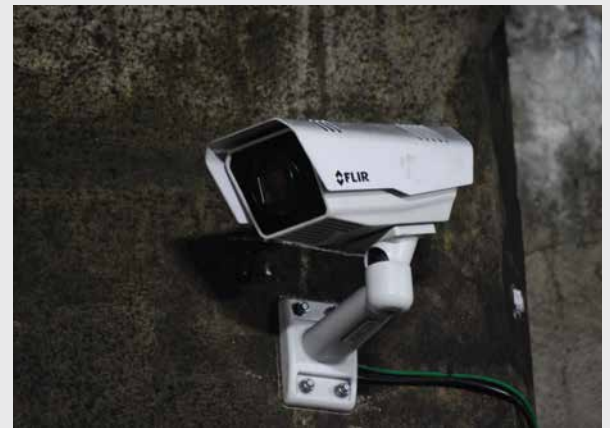
FLIR ITS-Series Rail. FLIR cameras ensure 24/7 detection on tracks or in tunnels and do not need any illumination to operate.

Infrabel now uses 30 FLIR ITS-Series Rail thermal imaging cameras to look for intruders inside the North-South railway tunnels. The thermal cameras pick up heat signatures from people entering the tunnel and, using smart algorithms, they can see whether it's a person or something else. Upon detection, an alarm is activated and a control room operator is warned of oncoming danger.

FLIR cameras ensure 24/7 detection on tracks or in tunnels and do not need any illumination to operate. The system uses advanced detection algorithms in order to accurately detect people without being triggered by unwanted objects like small animals or passing trains. Infrabel put forward a demanding requirement of 99% detection accuracy, which the FLIR cameras have been able to achieve.

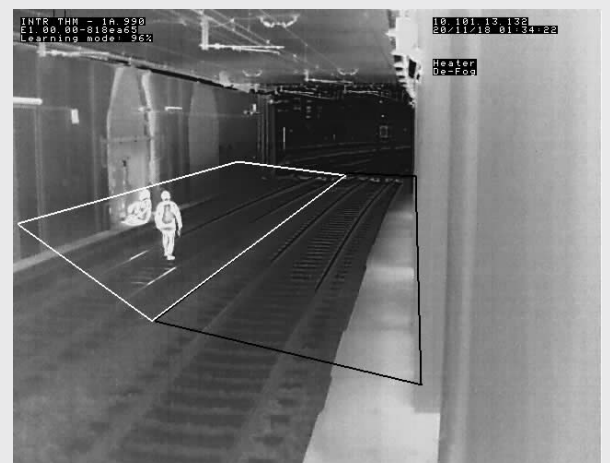
The thermal cameras pick up heat signatures from people entering the tunnel.

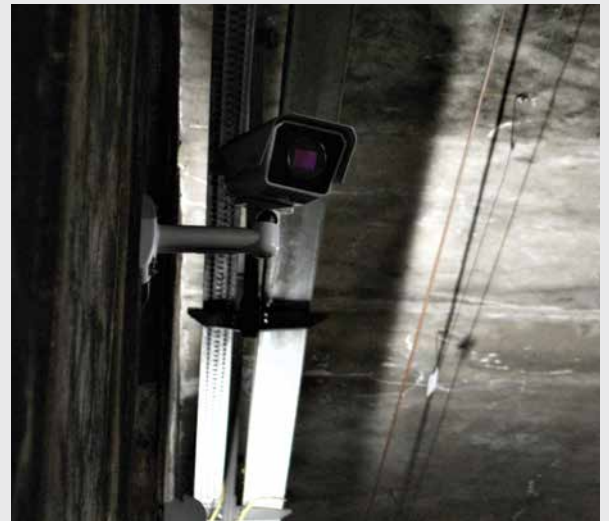
With the FLIR ITS-Series Rail cameras, the intelligence is built into the thermal imaging camera.

The accuracy is partly due to the system’s configurability. With the FLIR ITS-Series Rail cameras, the intelligence is built into the thermal imaging camera. According to Stefaan Vernieuwe, this makes it much easier to maintain the camera and configure it in function of its direct environment (e.g. to take into account lighting conditions).
