APPLICATION NOTE

Steel Manufacturing Inspection

STEEL INDUSTRY LEADERS USE FLIR GF346 CAMERAS TO DETECT HARMFUL CARBON MONOXIDE

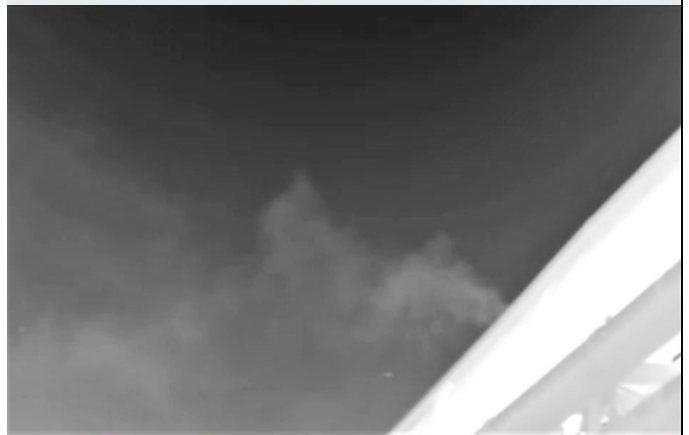
Image of a carbon monoxide (CO) leak in normal mode from a blast furnace during normal operation

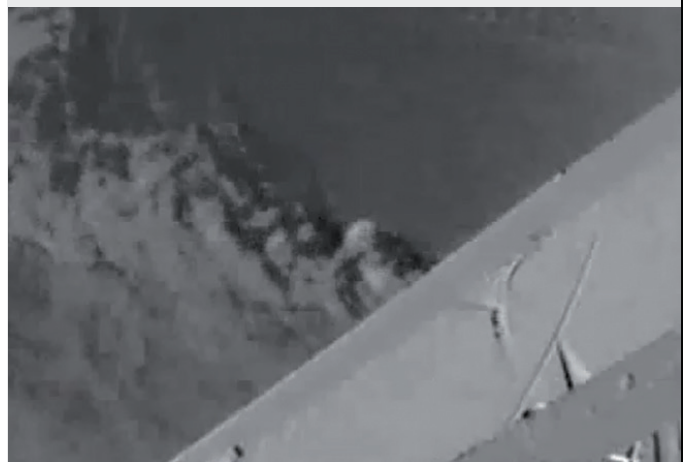
Image of a CO leak in high sensitivity mode (HSM) from a blast furnace during normal operation

and allows the user to pinpoint their source in real time. By ensuring there is sufficient Delta T (temperature difference between the ambient temperature at the leaking component and the background scene) technicians can achieve the optimal image contrast needed to detect the lowest level of gas emissions using the GF346's high sensitivity mode.

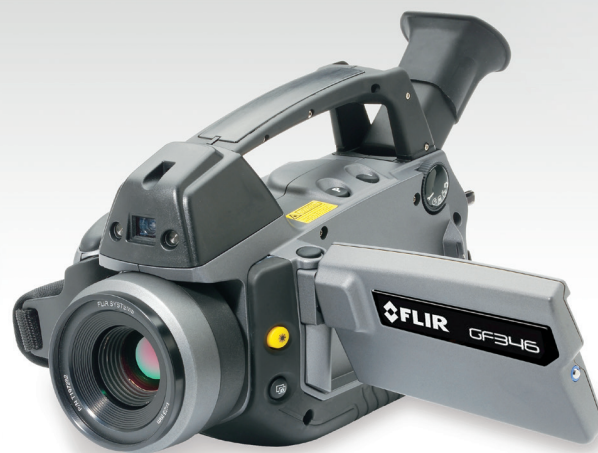
FLIR GF346 Infrared Camera for CO Detection and Electrical Inspections

The FLIR GF346 uses a specially filtered thermal detector to visualize CO and other harmful gases. The camera can be used to quickly scan for gas across wide areas and from a safe distance, without interrupting a plant's production process. CO emissions can be a significant threat to steel manufacturing operations so emissions need to be closely watched. Even the slightest leak in a vent stack or pipe can have a devastating effect. The FLIR GF346 scans potential leak points rapidly from a distance

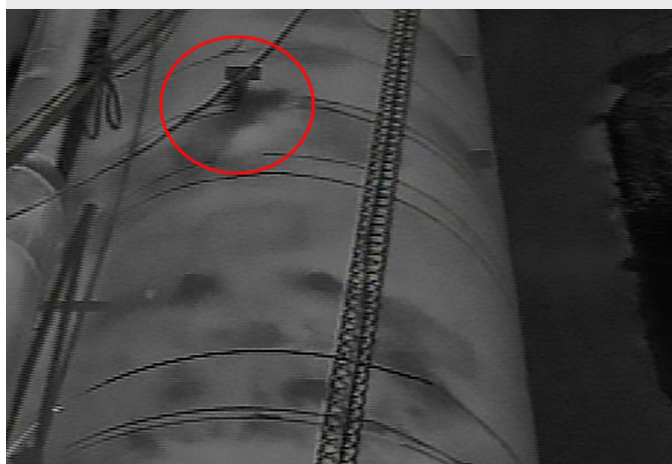
CO pipeline leak identified with a FLIR GF346 optical gas imaging camera

In addition to casting applications, there are extensive pipelines within steel production facilities with the potential for dangerous leaks. For example, during typical LDAR scans a user may not always find a leak in the steel making unit but can expand their inspection to gas lines outside the main facility premises. In these situations, the FLIR GF346 can detect leaks from main CO gas lines at a variety of points that supply gas to the hot strip mill furnace from gas mixing stations, like flange joints. As a result, a facility can develop a routine program to do pipeline scanning on a consistent basis. Using the GF346 to inspect connections, joints and other potential leak points provides an efficient way to further improve safety within a broader facility footprint and reduce emissions helping the organization meet environmental stewardship metrics.

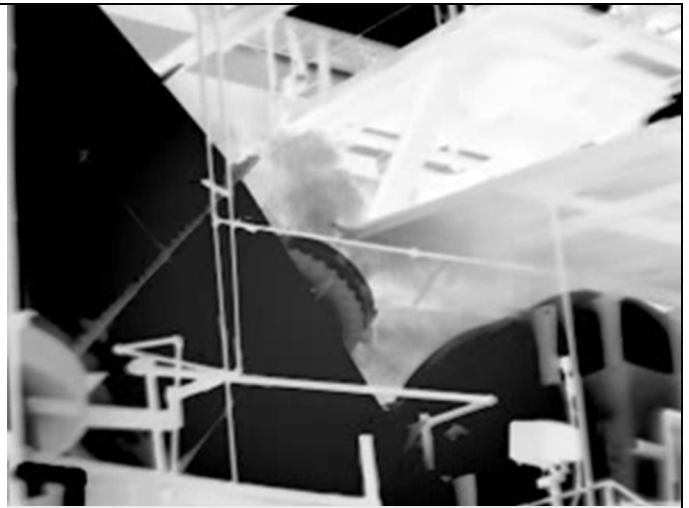
CO leak from a bleeder valve detected with the FLIR GF346 camera

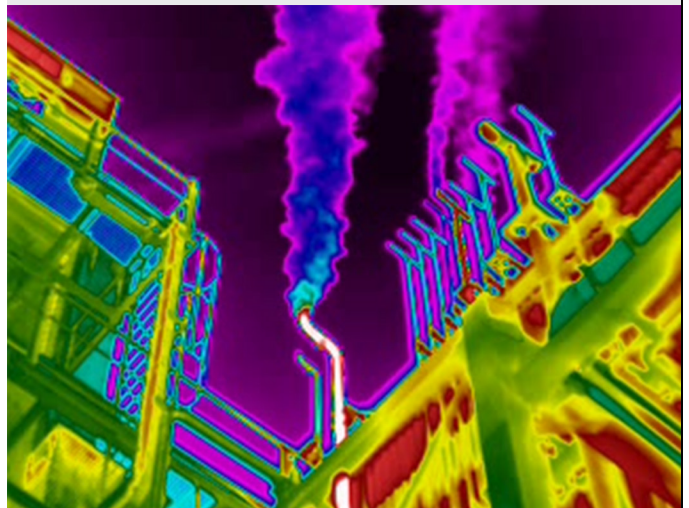
CO vent stack leak at a steel plant
