# MAINTENANCE INSPECTION WINDOWS ON TRANSFORMERS

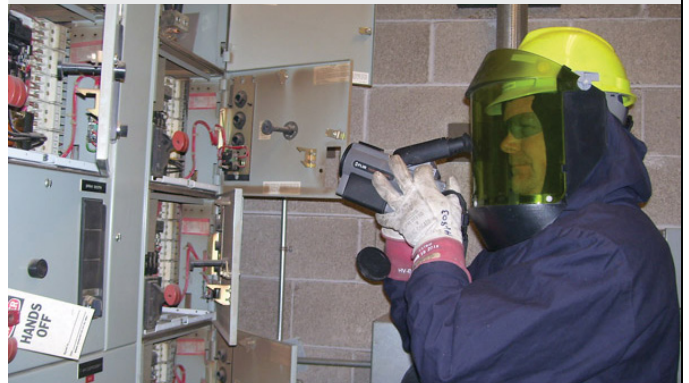
Infrared scanning is applicable on all electrical assets including motor control centers, but typically requires extensive PPE if done “open panel”

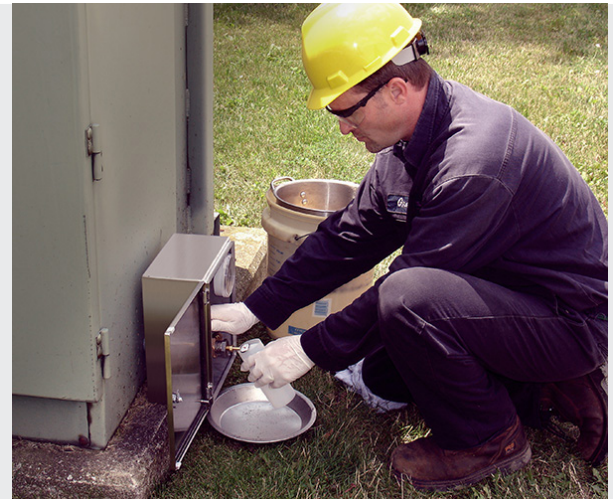
A safer oil sampling method retrofitted to an existing transformer allows energized sample collection; the sampling cabinet is lockable to prevent unauthorized access (Courtesy SDMyers)

Oil sampling ports can also be brought outside of the transformer cable compartment with several vendors offering retrofit kits that permit safe sampling as well as providing an optional external pressure gauge and nitrogen insert to relieve vacuum. Of course, contact ultrasound and PD (TEV) detection are performed on the external skin of the equipment in a closed condition and so no special Electrical Maintenance Safety Device (EMSD) is normally required for that type of inspection.

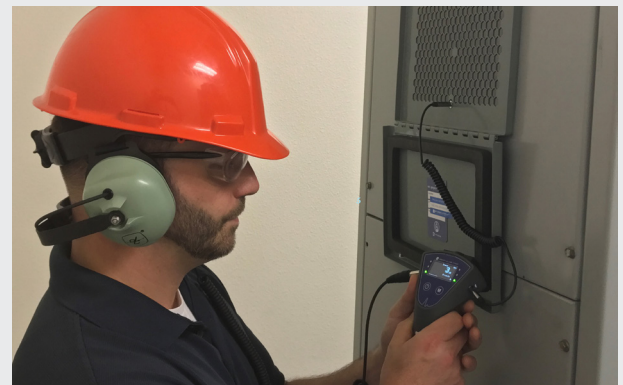
With a maintenance inspection window for visual, infrared, ultraviolet, and ultrasound inspections installed on medium voltage switchgear, no special PPE is required to use the EMSD

Maintenance Inspections Solutions, like those available from FLIR, can be installed on virtually any transformer and allow users to perform visual, infrared and ultraviolet inspections through a single device. Large format IRW-XPx rectangular windows mean that a single unit can be used for the LV connections and another for the HV connections on a transformer. While manipulating the cover of these types of windows, the equipment stays in a closed and guarded condition and the technician does not violate the restricted approach boundary so, per NFPA 70E Table 130.5 (C), they do not need to wear any special PPE as there is no increased likelihood of an Arc Flash occurrence.

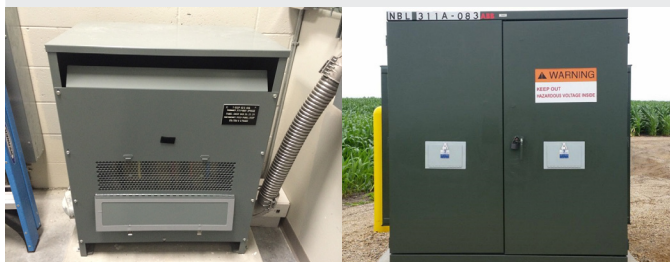
Custom replacement dry transformer panel-front with a built in maintenance inspection window

One large format maintenance inspection window is fitted on the LV side and another on the HV side of an oil-filled pad mount transformer allowing for inspection of all the internal connections
